Smart Care® TRIO

Air Vent Cleaning

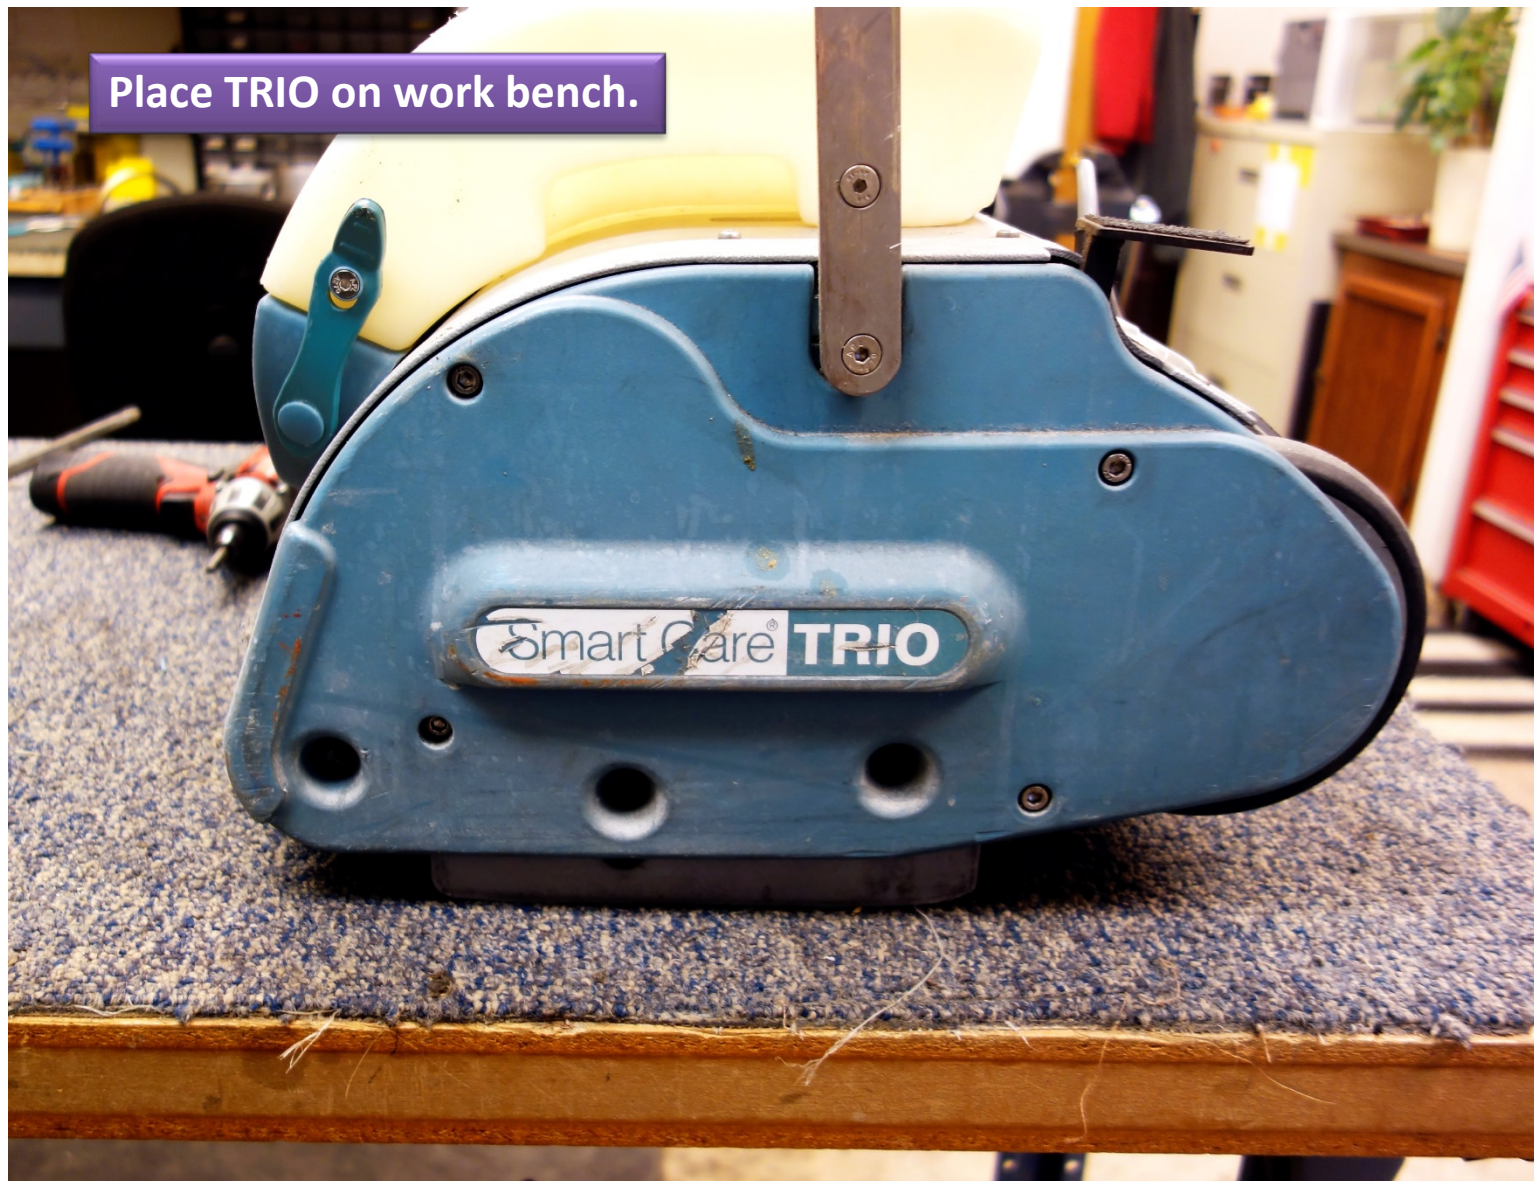
Place TRIO on work bench.

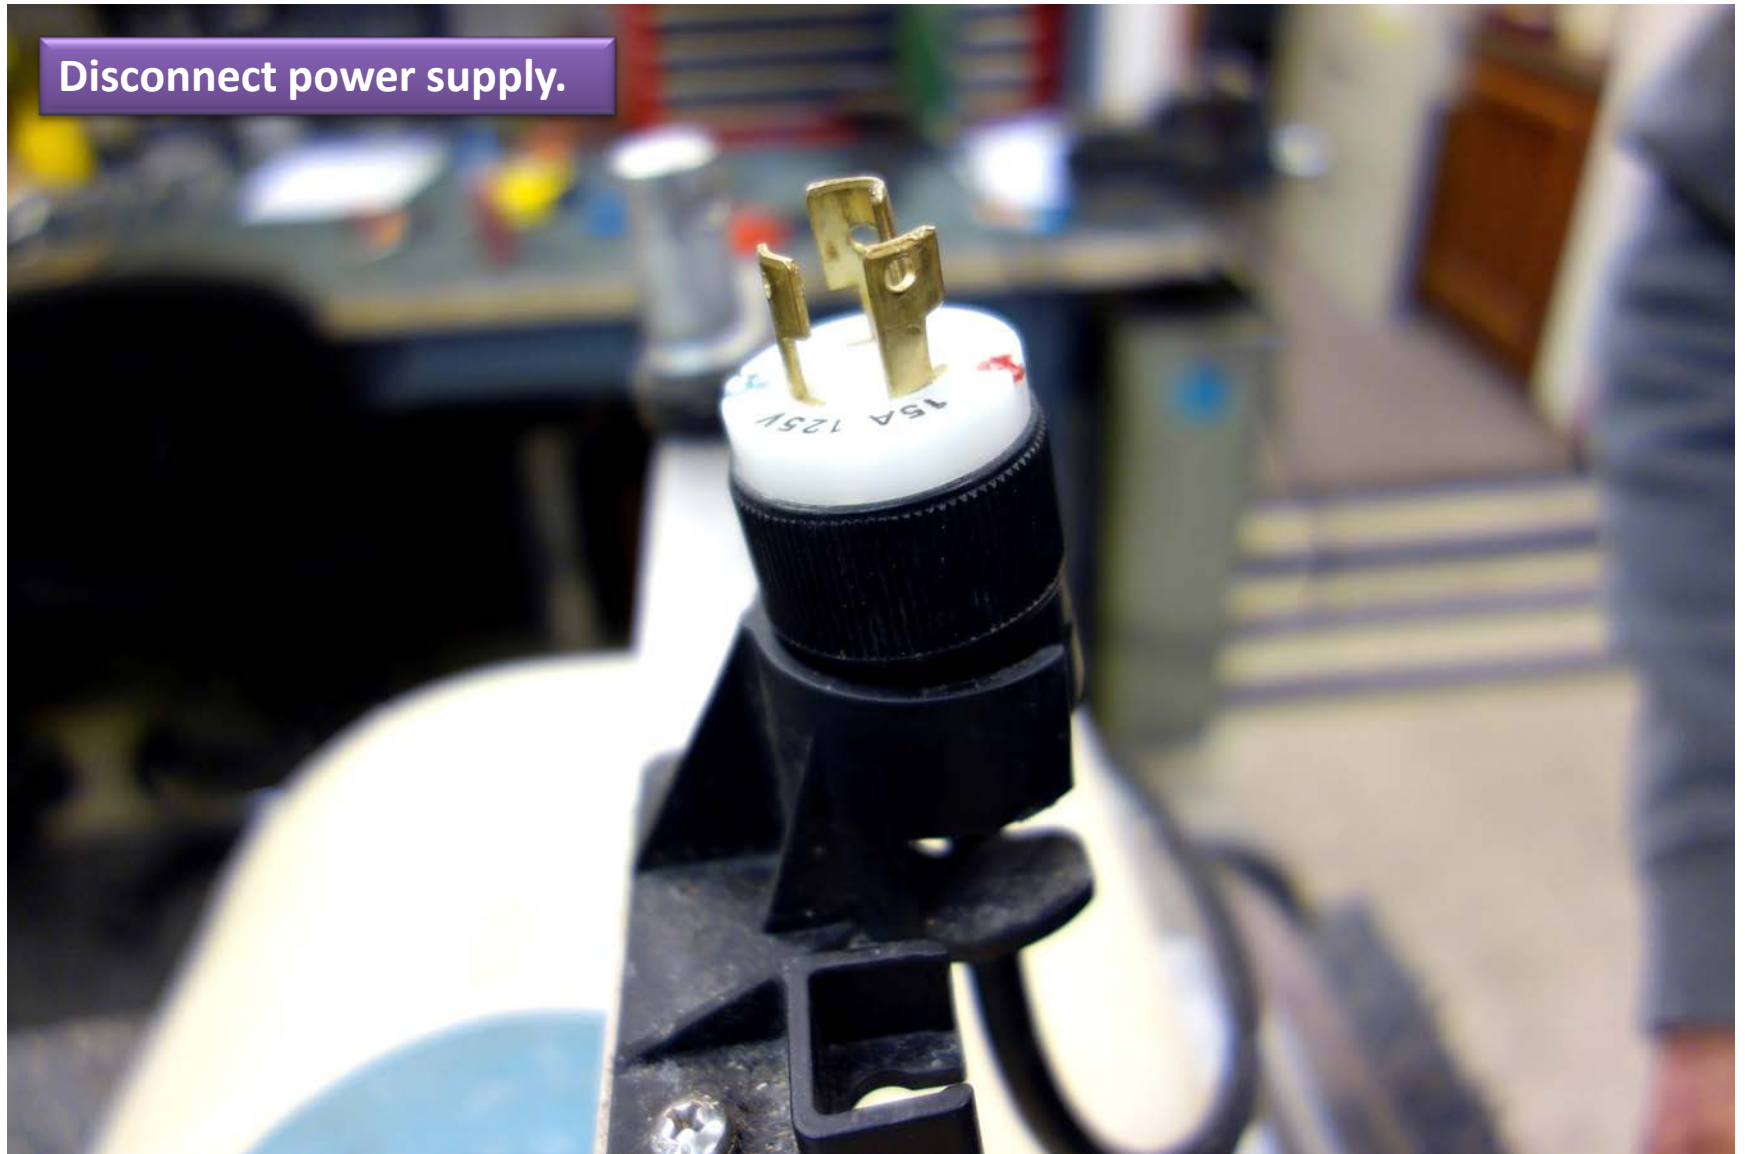
Disconnect power supply.

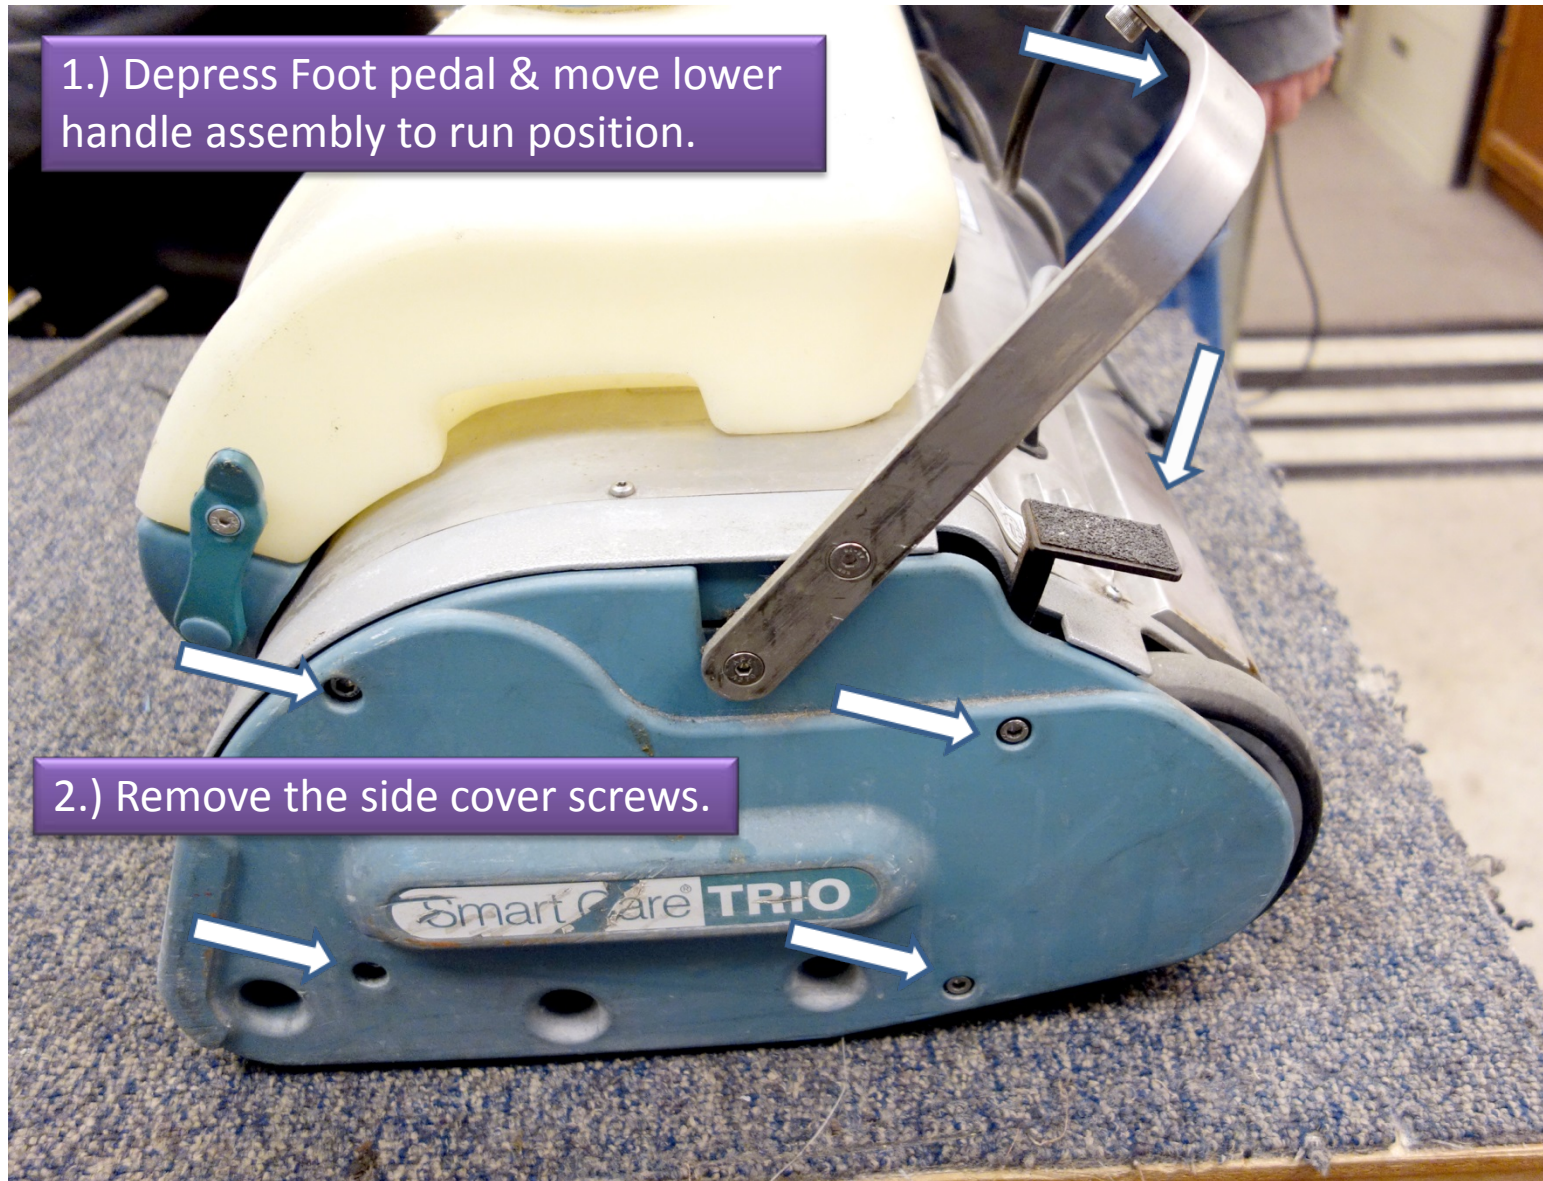
1.) Depress Foot pedal & move lower handle assembly to run position.

2.) Remove the side cover screws.

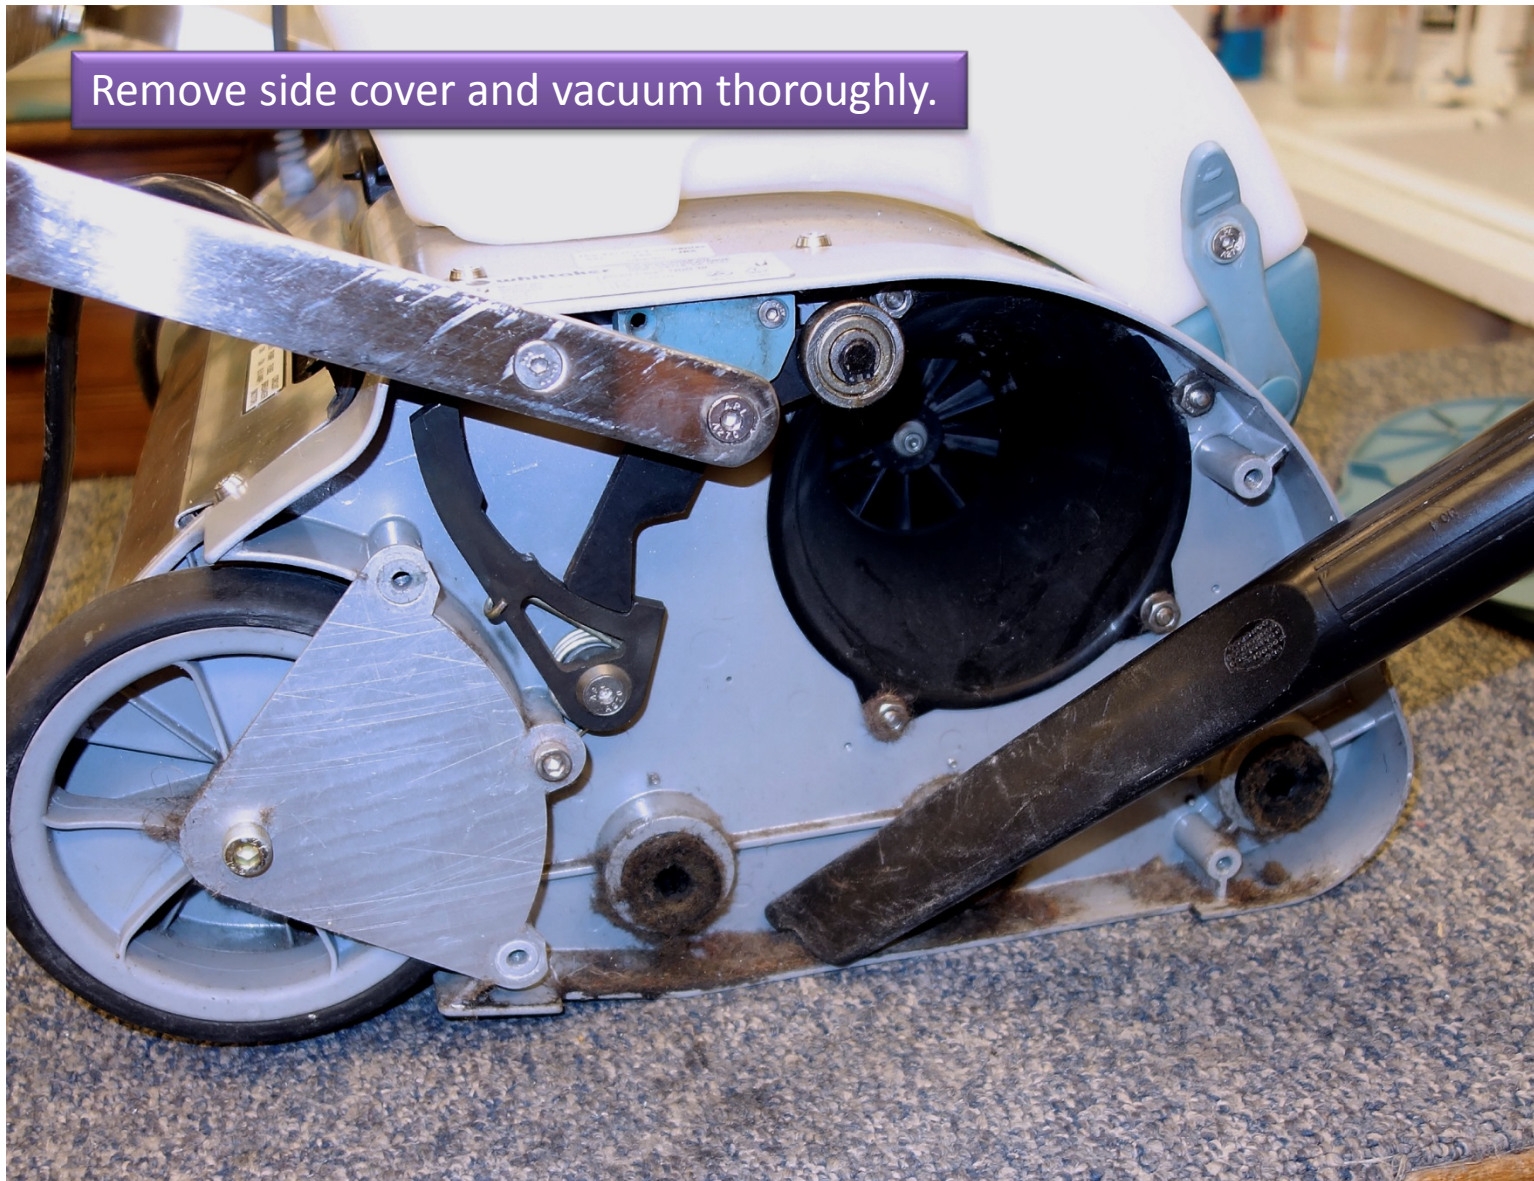
Remove side cover and vacuum thoroughly.

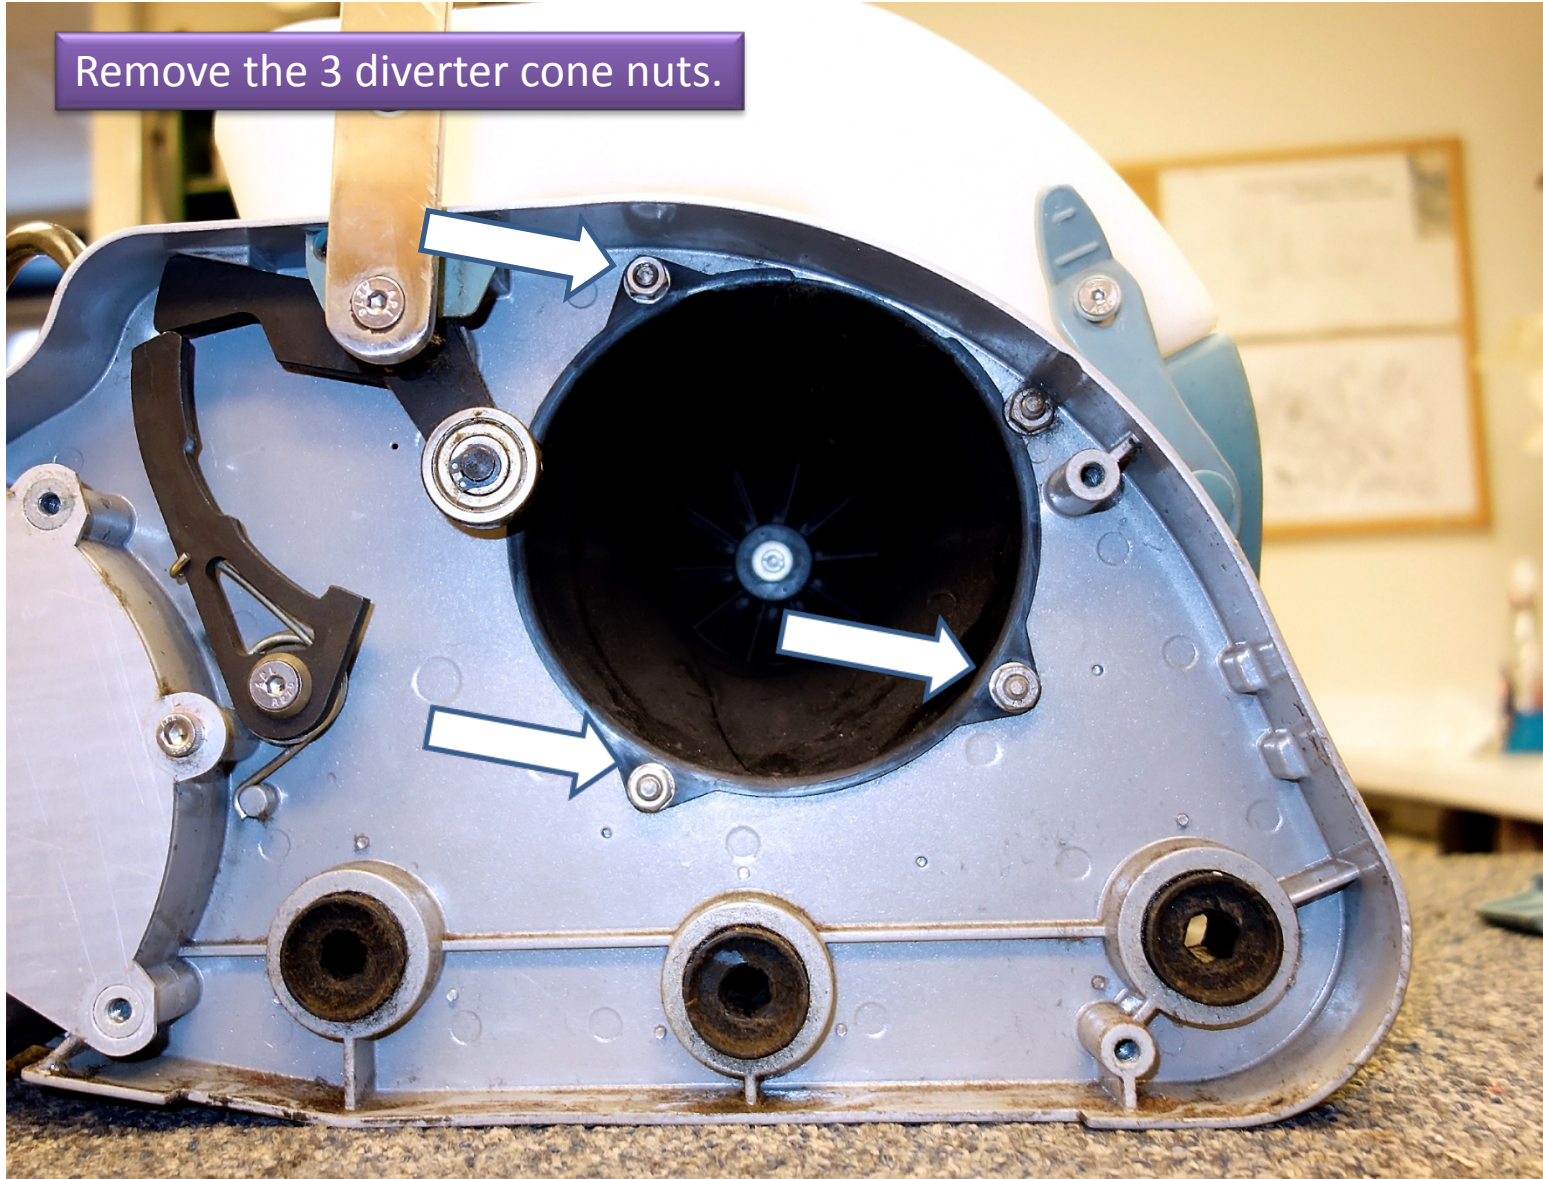
Remove the 3 diverter cone nuts.

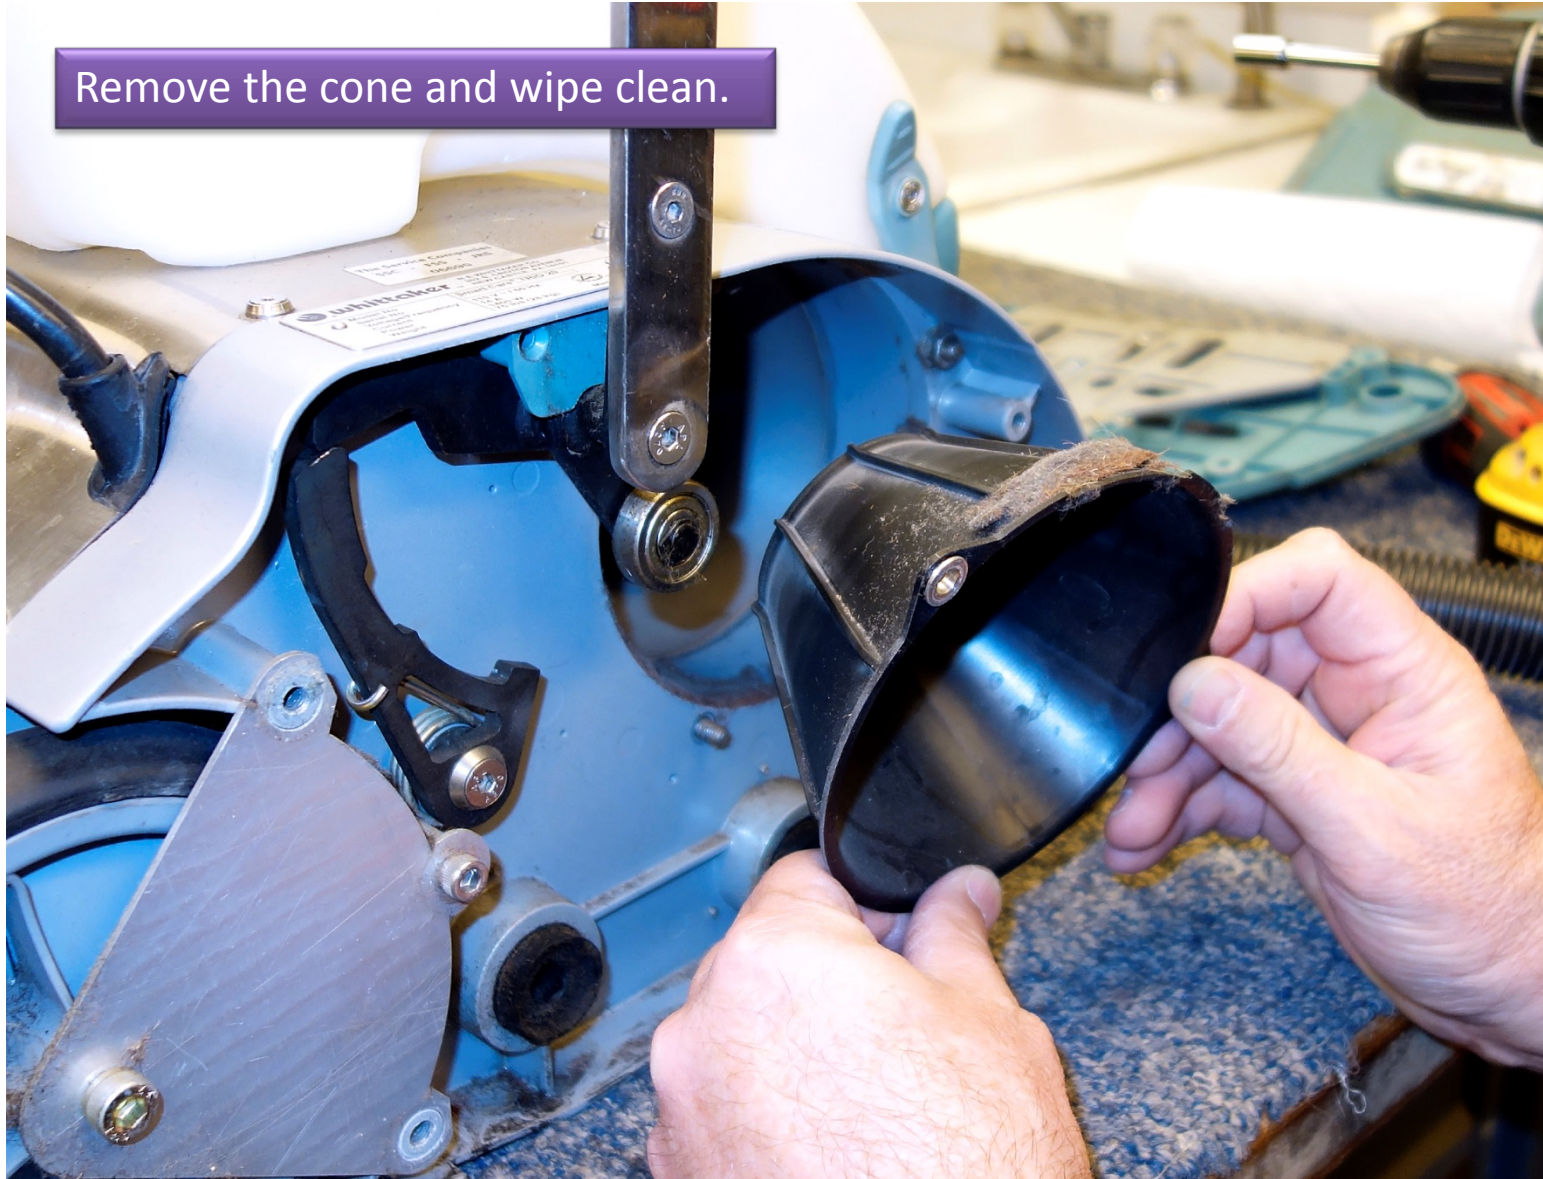
Remove the cone and wipe clean.

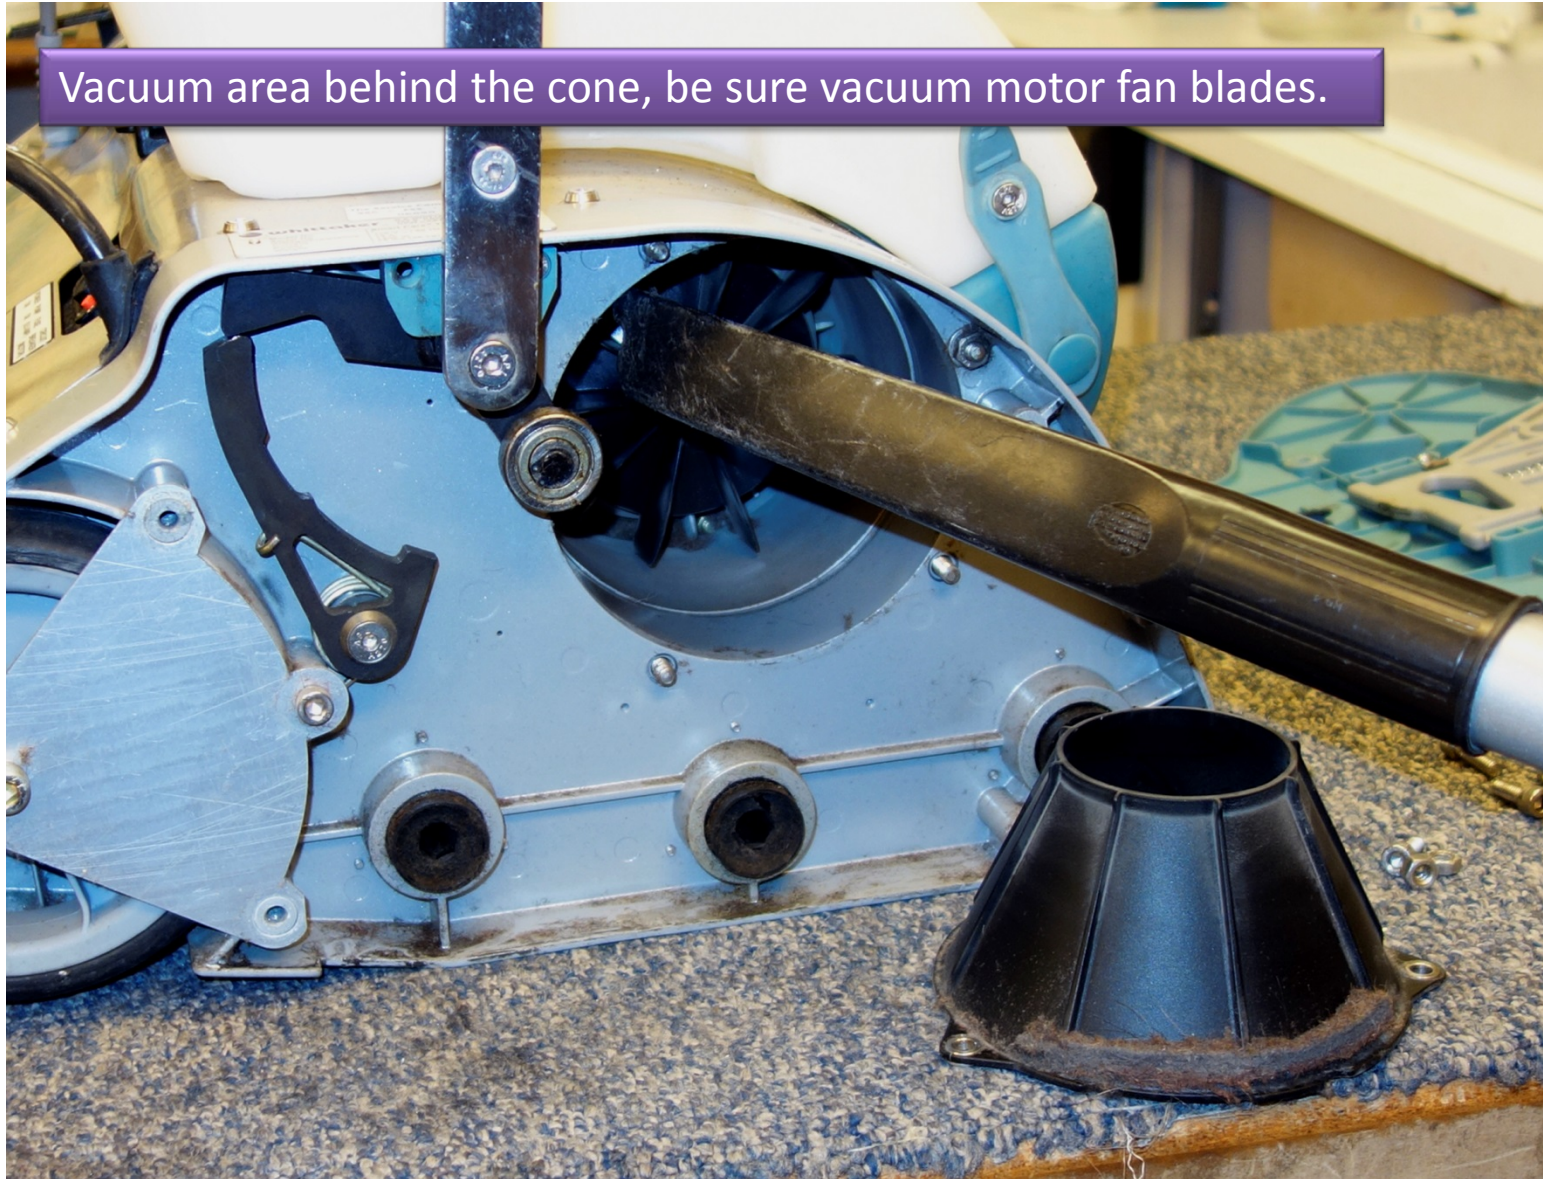
Vacuum area behind the cone, be sure vacuum motor fan blades.

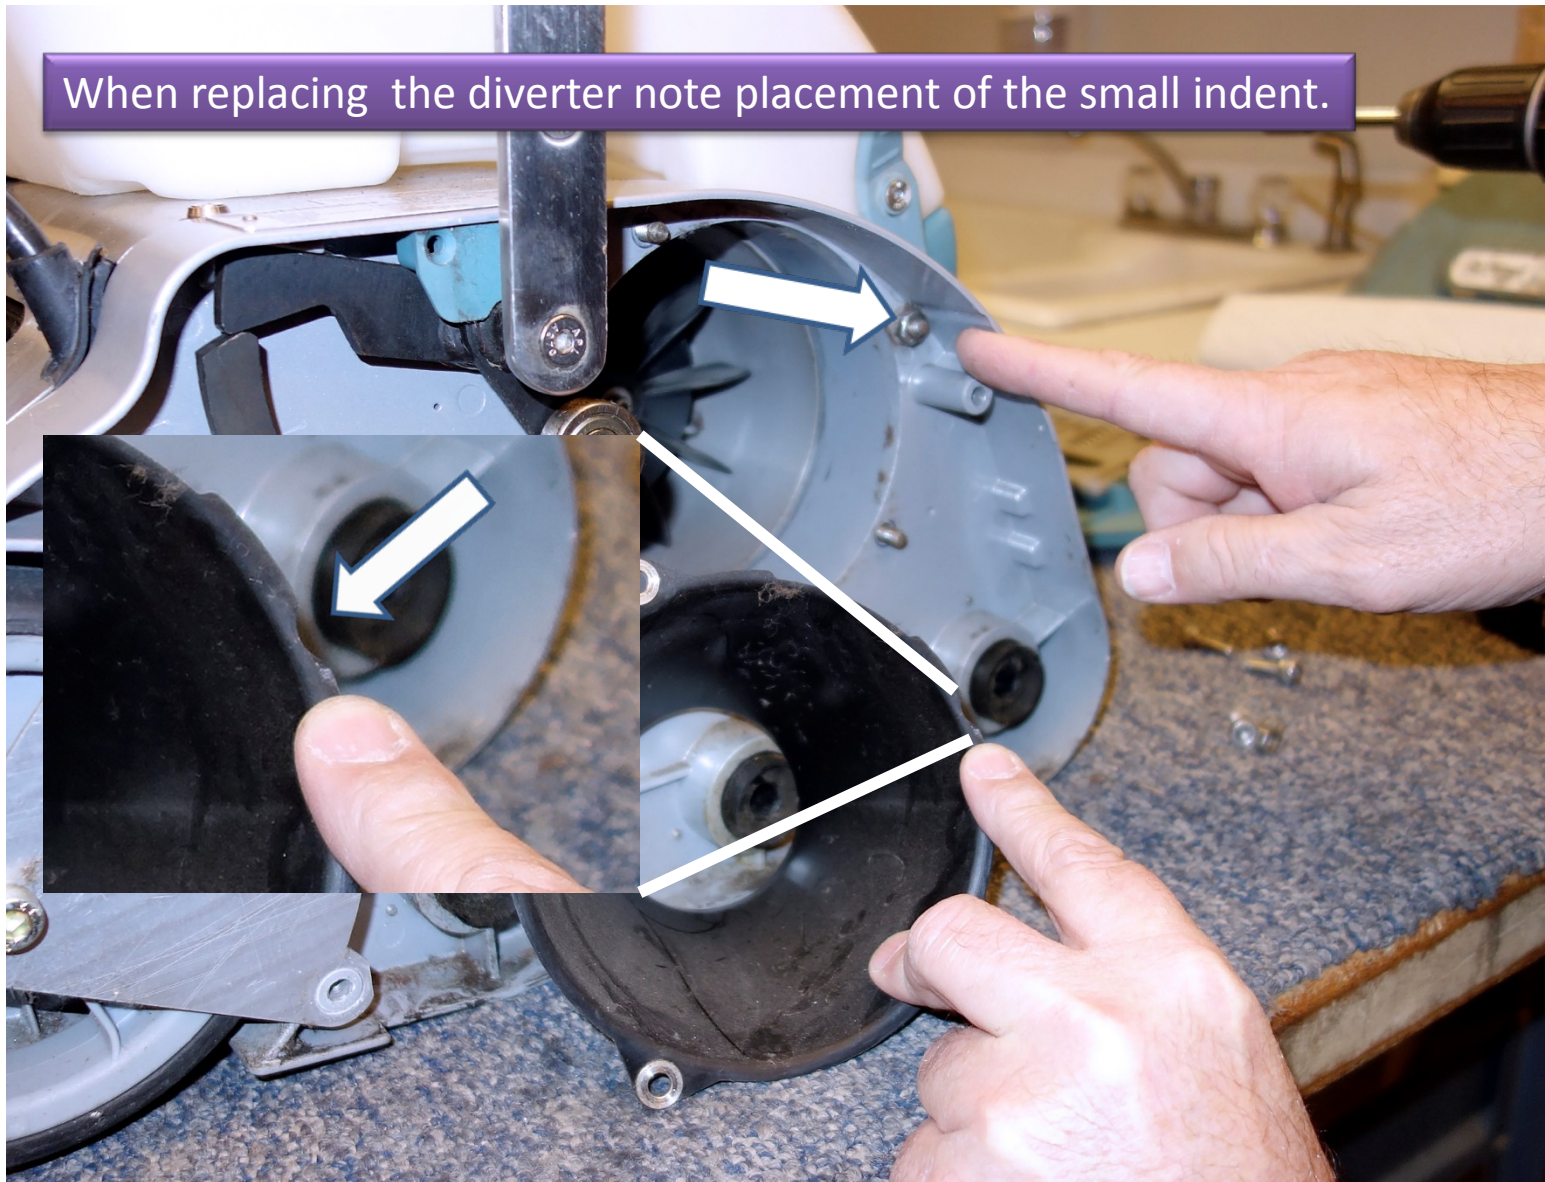
When replacing the diverter note placement of the small indent.

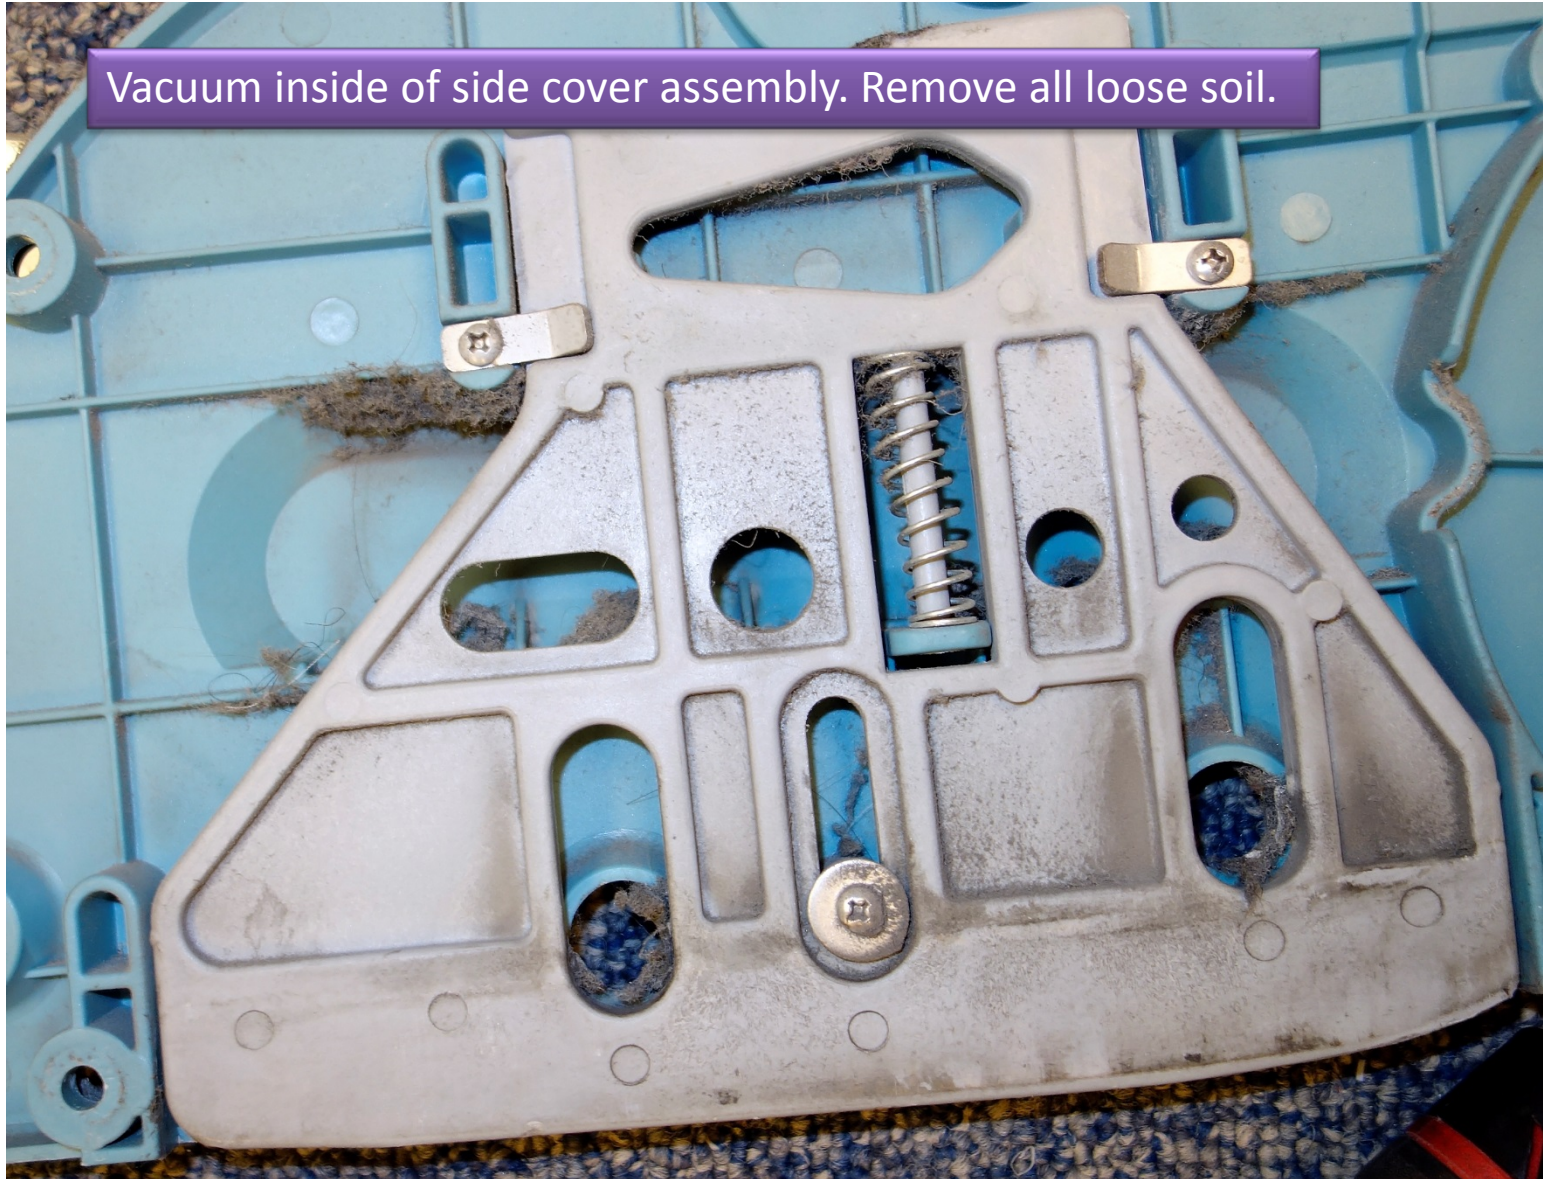
Vacuum inside of side cover assembly. Remove all loose soil.

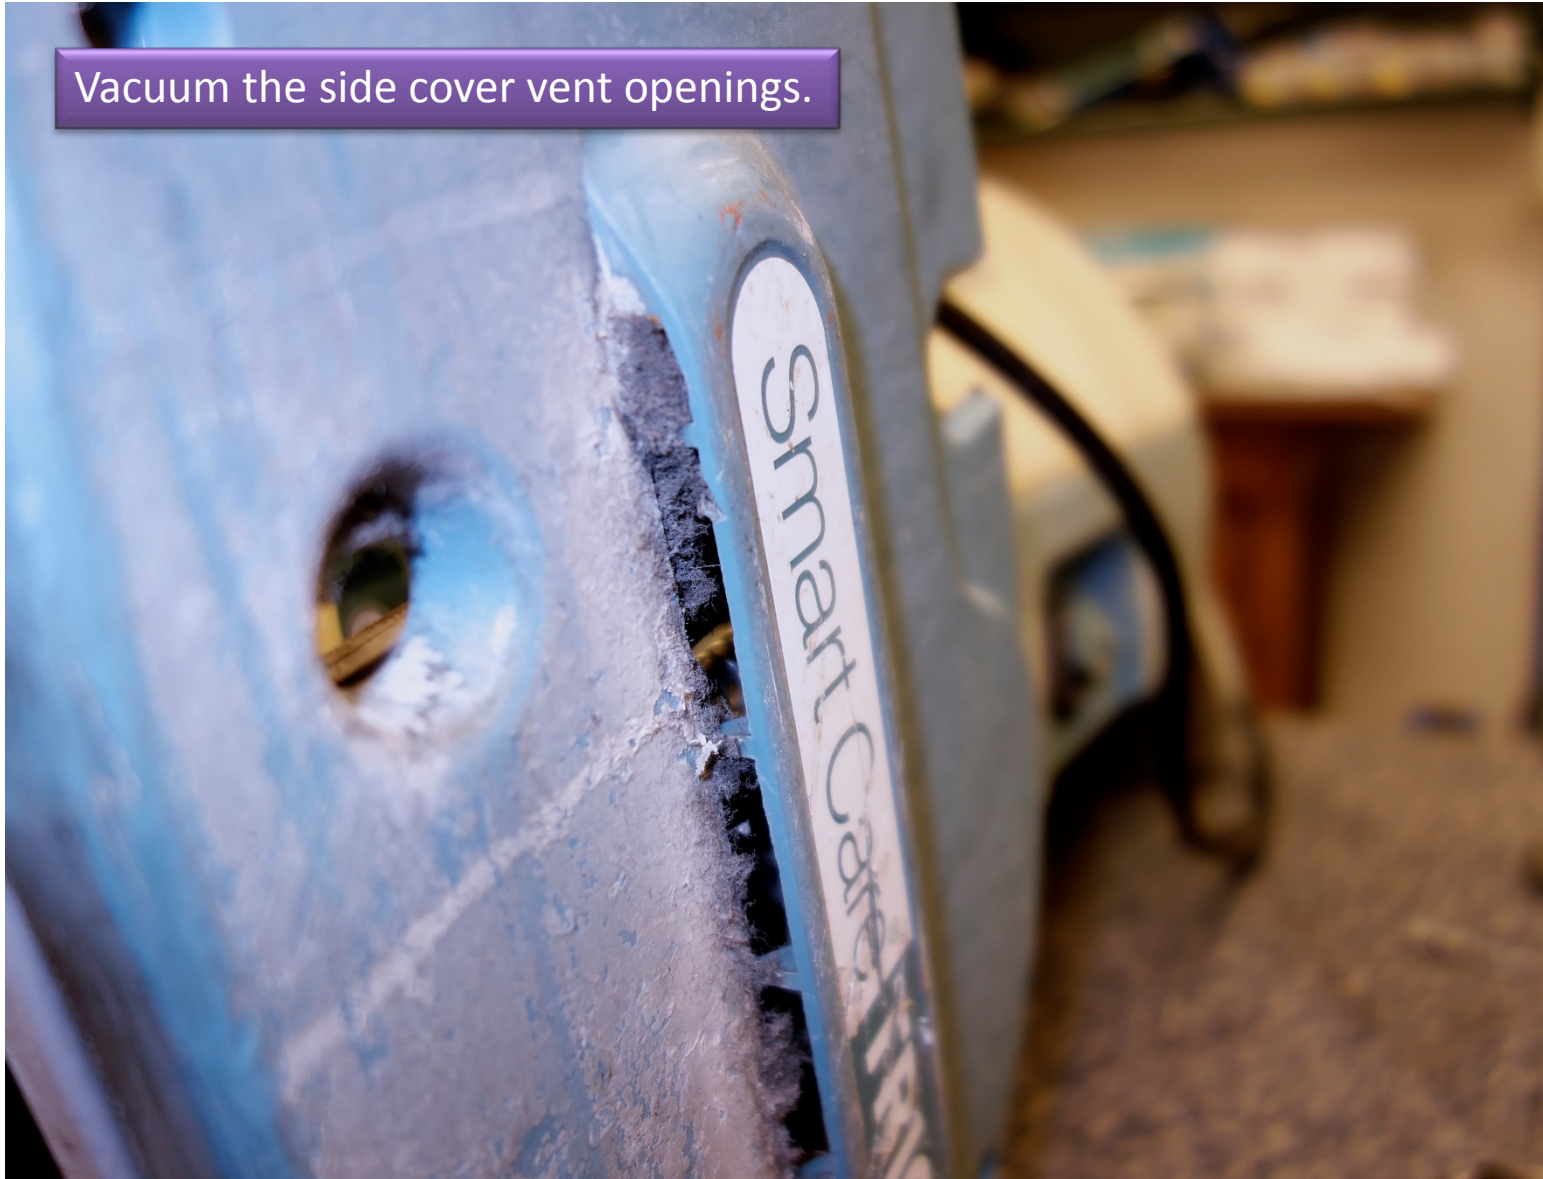
Vacuum the side cover vent openings.

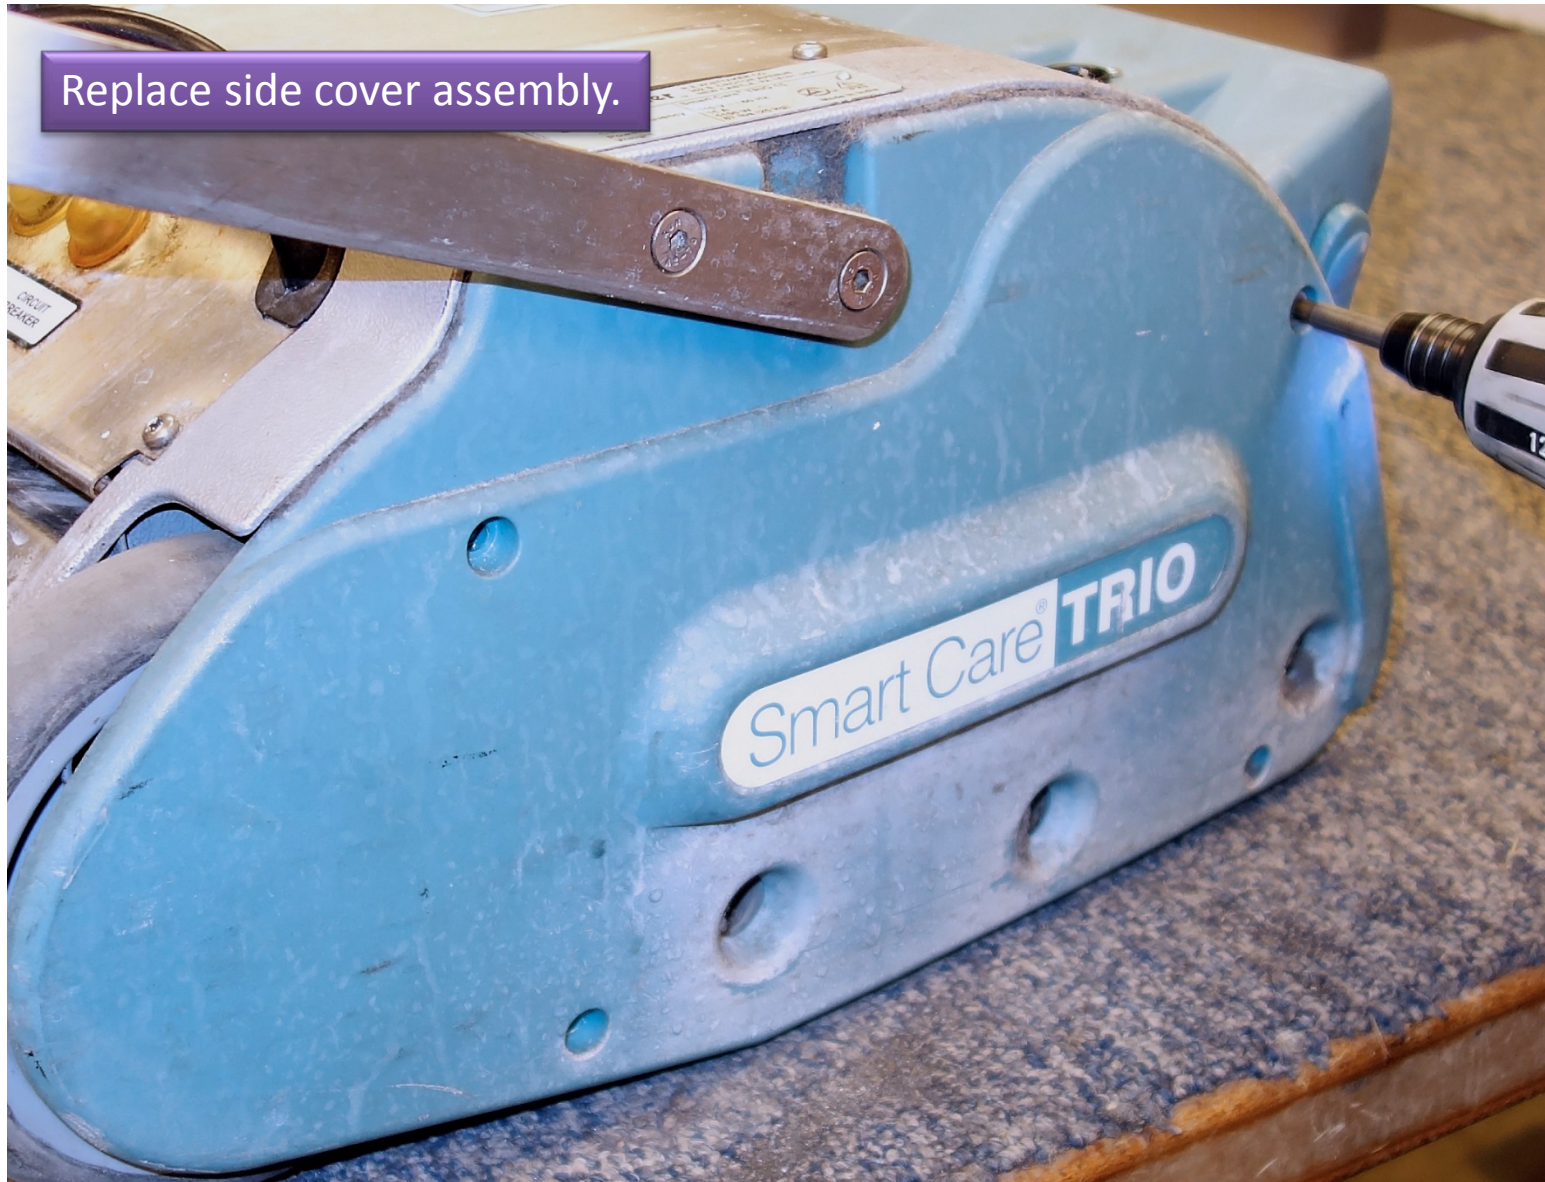
Replace side cover assembly.
